Cold Climate Fire Risk; A Case Study of the Lærdalsøyri Fire, January 2014

Abstract. Parameters leading to the severity of the fire in Lærdalsøyri, Norway, January 18th to 19th 2014, have been analyzed. The fire in the first villa developed significantly faster than the fire fighters could handle and the fire quickly spread to other structures. In addition to 36 modern buildings, 4 historic buildings in Gamle Lærdalsøyri cultural heritage area were lost. Heroic effort of local and neighbor community fire brigades, police, military forces and volunteers prevented the fire from destroying the whole village, including the remaining 157 historic buildings. Adiabatically heated (low humidity) air from surrounding high mountains gave outdoor wood fuel moisture content (FMC) of about 7.6%. Inside inhabited buildings, it is shown that the wooden products reached about 4.5% FMC prior to the blaze. When ignited, this resulted in rapid fire development. Two story villas burned down in less than 1 h while producing much embers and firebrands. Strong shifting winds subsequently spread the fire to neighbor houses by flame contact (periodically 20 m long horizontal flames) and over long distance

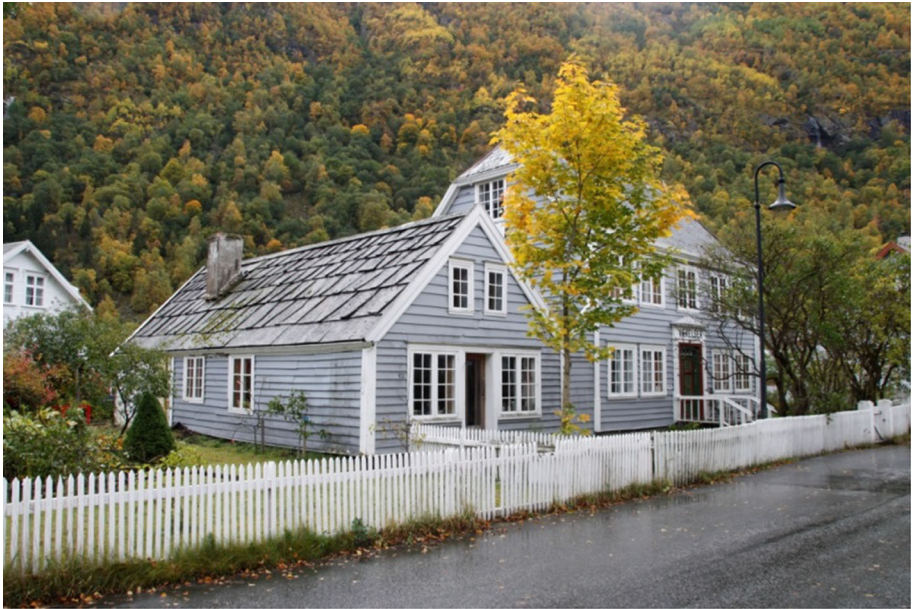
Figure 4. Synneva Eris house from ~1830 with the small adjacent building. (Photo by Arlen Synnøve Bidne.) Reproduced with permission. (The listed building was lost in the blaze January 19th 2014.).

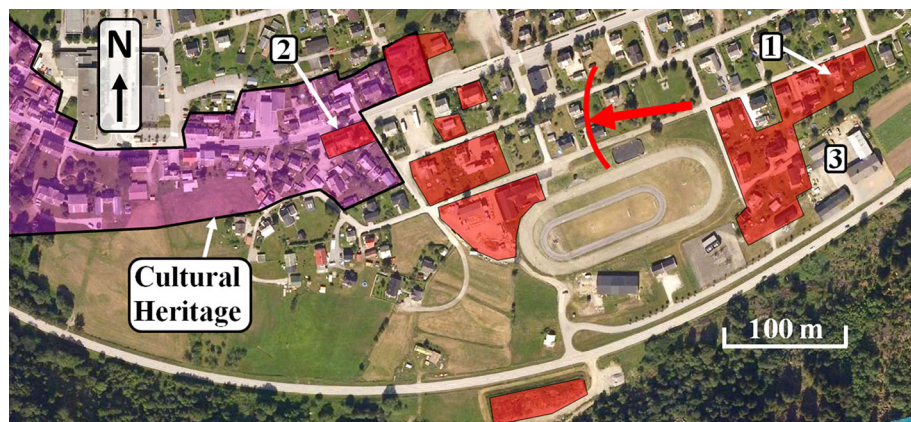
Figure 5. The Lærdalsøyri conflagration area. The most frequent wind direction (storm strength) during the blaze is marked with red arrow. Areas marked in red were destroyed in the fire, involving 4 houses in the cultural heritage area. 1 House of fire origin. 2 Synneva Eris house from ~1830. 3 Fire station.

120 s after the fire call was made [3]. He observed that the first house had already passed the stage of flashover and burned in a fierce way exceeding what he had previously experienced in fires. The whole house was burning, including the external wooden sidings. When he shortly afterwards arrived with the fire truck to start fighting the fire, the flames emerging from the first house were tilted horizontally by the wind, now touching the neighbor house 15 m to the west.

The storm strength wind occasionally eased off and suddenly changed 180° direction followed by full strength in the new direction. The horizontal flames, up to 20 m to 30 m length and shifting $\pm 180^\circ$, represented a serious threat to the fire fighters. They frequently had to reorganize according to the shifty wind seriously hampering their efforts to control the fire. Such wind shifts are common in Lærdalsøyri in strong easterly gradient winds [4]. This phenomenon is probably caused by large scale turbulence effects from the high mountains, the winding valley and the Sognefjorden fjord systems, all exerting strong influence on any local winds in Lærdalsøyri.

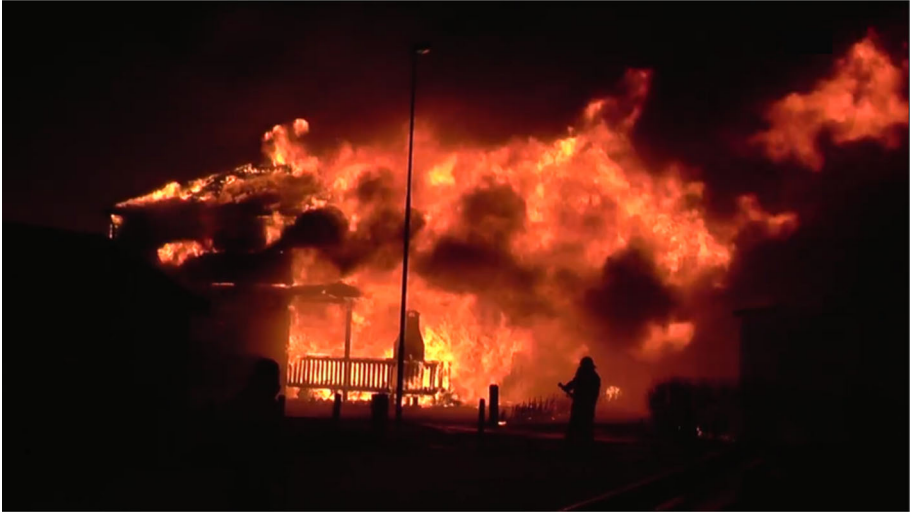
Figure 6. 20 m to 30 m long nearly horizontal flames from a villa early in the developing blaze. (Photo by Geir Trulssen). Reproduced with permission.

The fire fighters reported clean burning (comparably small amounts of soot) and orange flame colors. This flame color and massive embers production were also reported by journalists on the scene and confirmed by numerous photos and videos of the developing conflagration, see Figures 6 and 7. A detailed description

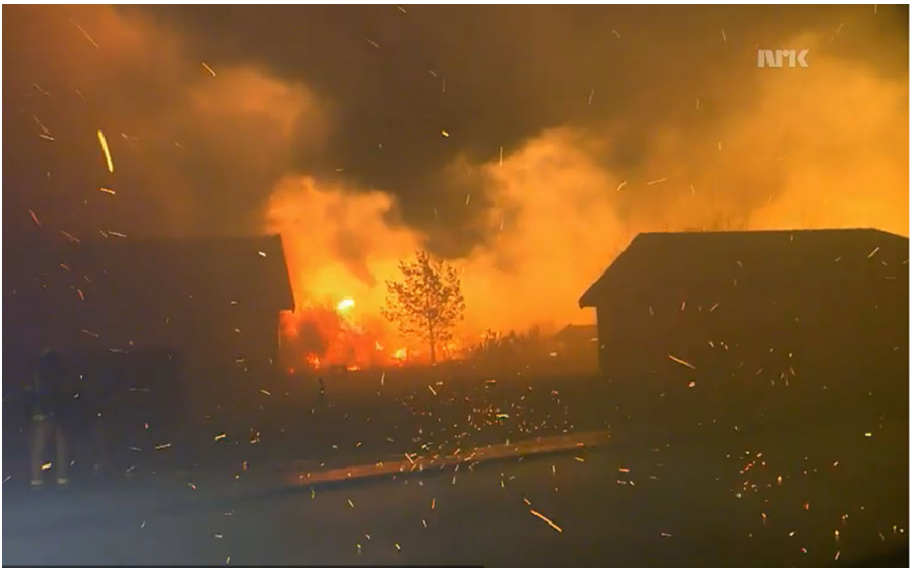
Figure 7. Airborne glowing embers and debris during the fire in Lærdalsøyri. (Photo by Arve Uglum, Norwegian Broadcasting Corporation (NRK)). Reproduced with permission.

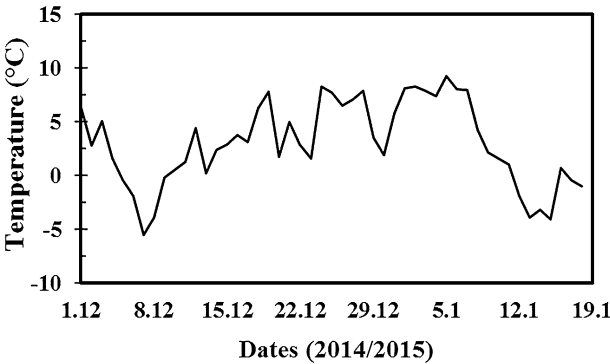
Figure 8. Daily average temperatures (Lærdalsøyri meteorological station) prior to the fire.

The daily average temperature and precipitation prior to the fire are shown in Figures 8 and 9, respectively (data from the Norwegian Meteorological Institute, eklima.no database). In the 40 days period prior to January 18th, the accumulated precipitation was 13.4 mm. The normal for this 40 days period is close to 60 mm, i.e. the precipitation prior to the fire was significantly less than normal. Other factors may also exert influence on the dryness of an area. As an example, the relative humidity at costal Flesland airport (Bergen) in the actual period is shown in Figure 10. It turns out that winds from the east give very low relative humidity at that airport. At Flesland, in the bottom left corner of Figure 1, winds from the

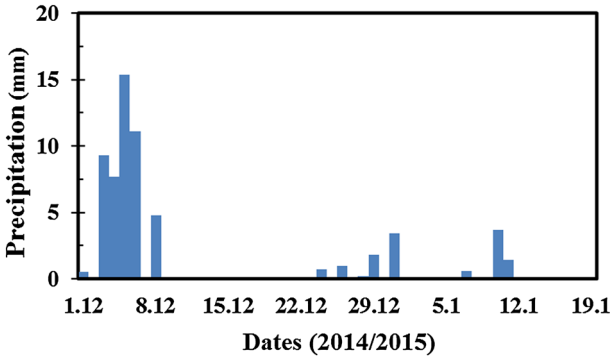
Figure 9. Precipitation (Lærdalsøyri meteorological station) prior to the fire.

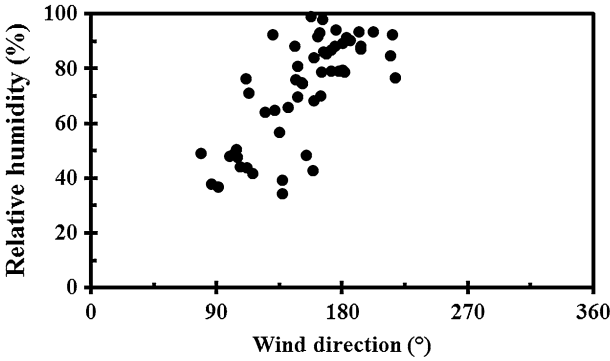
Figure 10. December 9th to January 30th average daily relative humidity at Flesland meteorological station (Bergen) as a function of wind direction.

Lærdalsøyri is, as seen on Figure 1, surrounded by mountains. Only wind from due west (270°) can get into Lærdalsøyri without passing over major mountain areas. According to Figure 10, there were no (whole) days of average wind from west during the last 40 days prior to the fire. This indicates that virtually all wind had passed over major mountain areas before entering the Lærdal valley.

The author lives in a 30 years old wooden house in Western Norway, i.e. similar climate and humidity levels as Flesland (Figure 10). It was exceptionally dry and windy in January 2014. In the middle of the month, the solid oak lacquered panels in the sitting room floor for the first time ever detached leaving 1 mm to 2 mm gaps between several of the individual panels. The oak panels dried out either through the colorless protective lacquer or through the shielded surface through the rock wool insulation between the ground floor and the first floor. The author then realized that the humidity levels were very low inside the house and warned wife and children about an exceptional fire risk. A neighbor recorded 18% RH inside their wooden house. Still, probably only the few driest days along the coast were comparable to the situation in Lærdalsøyri.

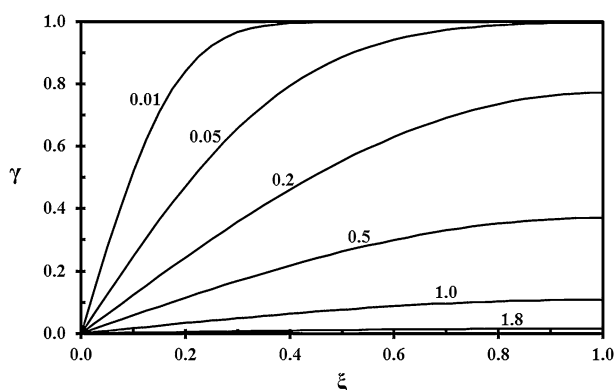
Figure 11. Humidity concentration in wood panels exposed to dry air, i.e. Eq. 7 ($\xi = x/l$), with Fourier numbers marked on the curves.

A plot of Eq. 7 for different Fo is shown in Figure 11, where $\gamma = 1$ represents the EMC at the previous humid air condition and $\gamma = 0$ represents the EMC for the new drier air condition. Typical diffusion coefficients of water in wood are in the range 1 to $5 \times 10^{-10} \text{ m}^2 \text{s}^{-1}$ [21]. Assuming now that a 10 mm thick wooden panel is exposed to the drier climate on one side during a 40 days period, even the lowest of these diffusion coefficients gives $Fo > 1.8$. According to Figure 11, this indicates that wood panels and other thin wooden objects exposed to the dry air reached their corresponding low EMC values well within January 18th. Thin branches on garden trees, hedges, house sidings, etc. were therefore very dry.
